**SUBJECT: START 3, EPA Region 8, Contract No. EP-W-05-050, TDD No. 1008-13
Trip Report for August 2011 Sampling and Field Activities, Upper Animas Mining
District, Silverton, San Juan County, Colorado**

TRIP REPORT
Upper Animas Mining District
Silverton, San Juan County, Colorado

**Photo Log
Cement Creek
San Juan County, Colorado
August 2011**

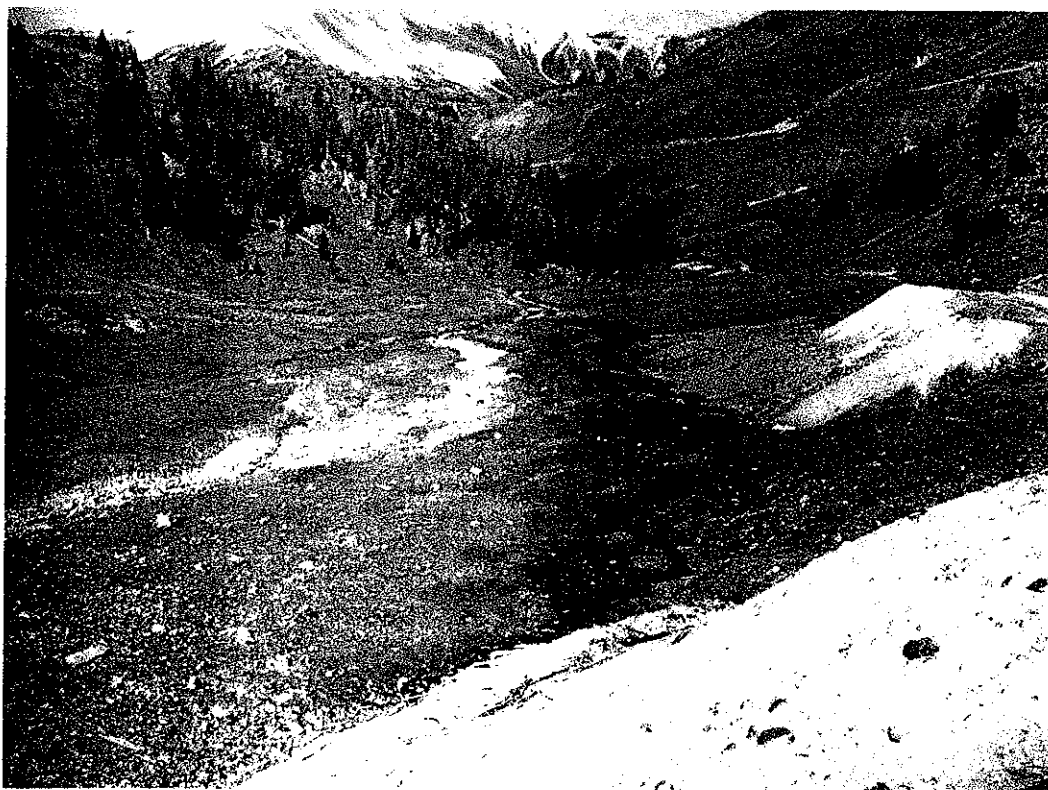
PHOTO 1

View to the west of surface water flowing from the toe of the Grand Mogul Mine waste rock dumps toward Cement Creek. Note iron staining of flow path.

- **Grand Mogul Mine:** The overland flow pathway for the Grand Mogul Mine begins at the western toe of the main waste rock pile and continues westward for approximately 300 feet until it enters Cement Creek (Appendix A, Photos 1 & 2). The overland flow path as shown in Photo 1 is heavily stained with iron oxides (that begin to precipitate out of solution when the pH rises above 3.5) as compared to the stream course of Cement Creek on the left center of the photograph.

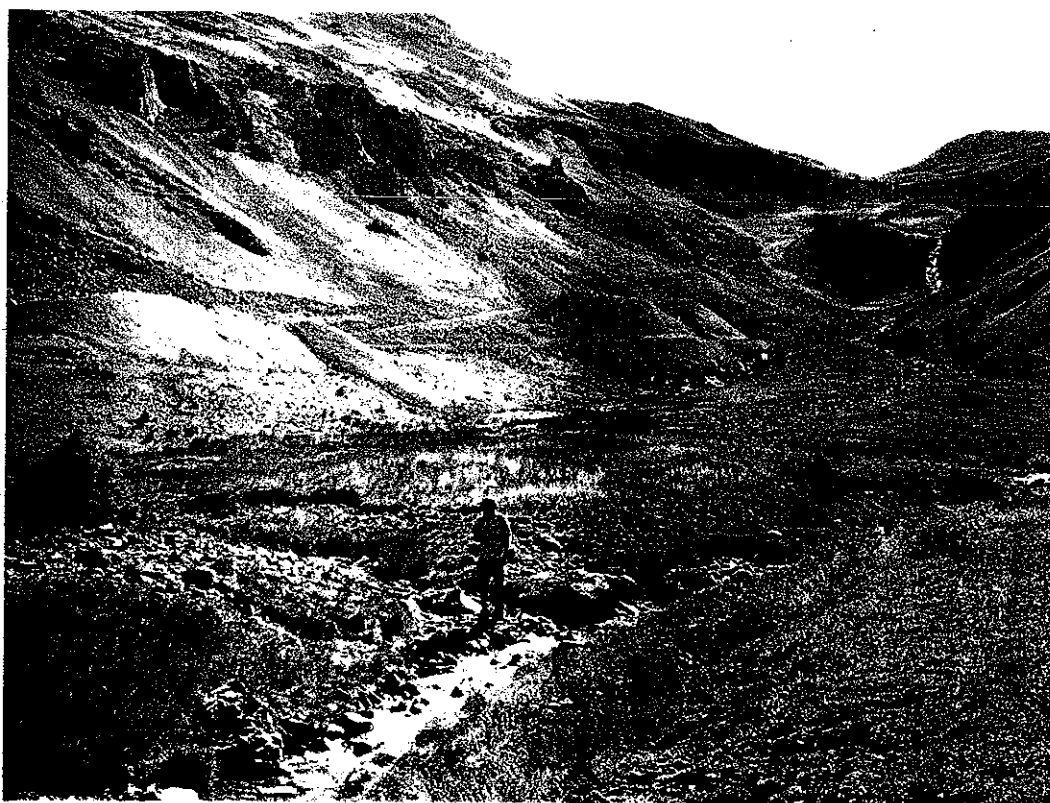
PHOTO 2

View to the east of the PPE from the Grand Mogul Mine into Cement Creek. Note iron staining of rocks in Cement Creek downstream of flow from Grand Mogul Mine. J. Miller of START at PPE collecting GPS location data.

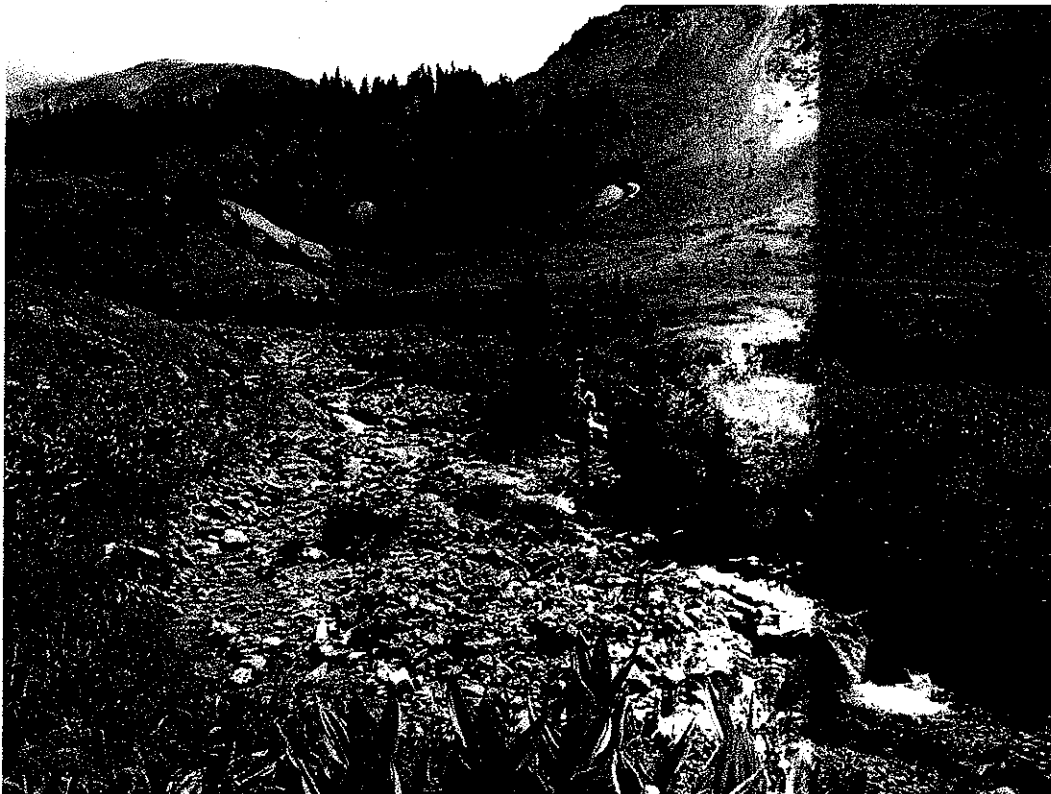
PHOTO 4

View to the east of the PPE of the discharge from the Mogul Mine into Cement Creek. The surface water pathway from the adit flows down to the road on the other side of the white patch of waste rock and through the wetlands. Note iron staining of Cement Creek on the inflow side of the creek from the PPE where J. Miller of START at PPE collecting GPS location data.

- **Mogul Mine:** The discharge from the Mogul exits through an adit on the northeast side of the waste rock pile and flows across the top of the waste rock pile in a tarp lined ditch to the access road. Once the adit discharge crosses the road, it flows over a mixture of mine waste rock and mine trash into a series of wetlands below the mine (Appendix A, Photo 3). The overland flow pathway from the Mogul Mine covers approximately 1,200 feet before the PPE into Cement Creek. It can be observed that iron oxides are precipitating on the side of Cement Creek where discharge water from the Mogul Mine is entering Cement Creek (Appendix A, Photo 4).

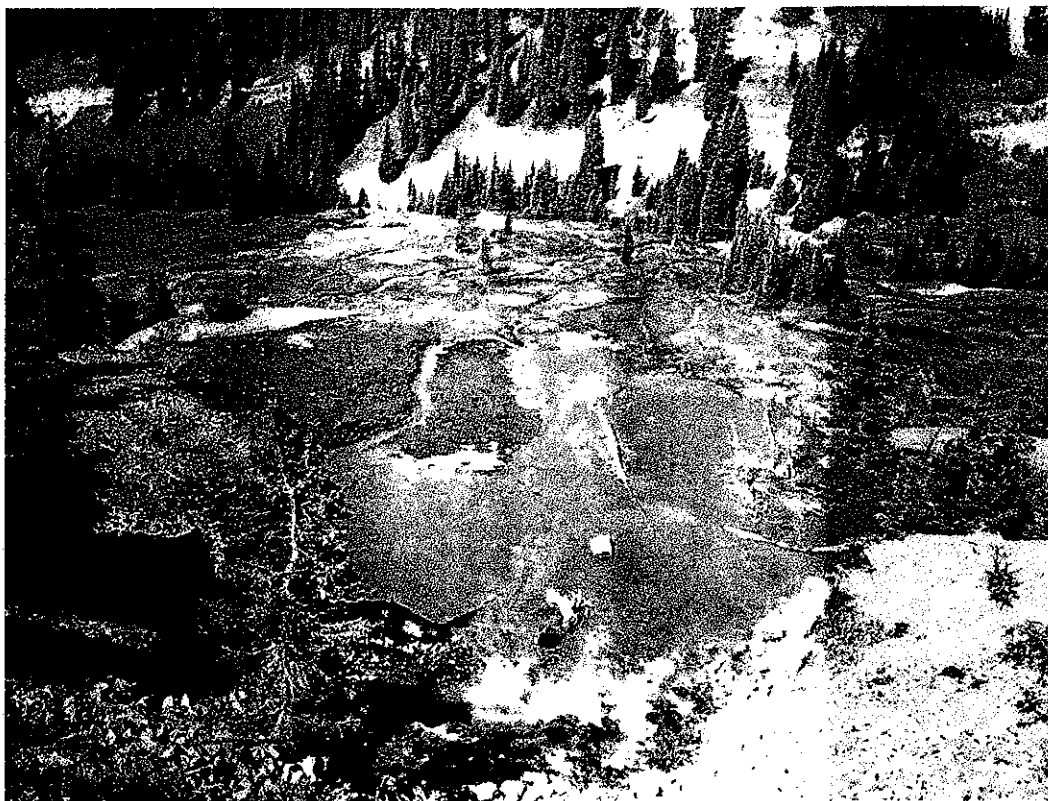
PHOTO 5

View to the west of the adit discharge from the Red and Bonita Mine. Note the strong color of iron oxide precipitation and the staining to Cement Creek along valley floor.

road, and then directly westward across a barren iron oxide stained landscape to Cement Creek (Appendix A, Photo 5). The overland flow path after flowing under the road splits into two streams in the barren area after the road and before entering Cement Creek. The more upstream flow path was visually estimated to carry approximately 75 percent of the flow, and the smaller stream enters Cement Creek approximately 50 feet downstream of the larger stream. Photo 6 shows the upper dominant discharge point. Note the iron oxide staining in the Cement Creek streambed on the side of the PPE from the Red and Bonita Mine (Appendix A, Photo 6).

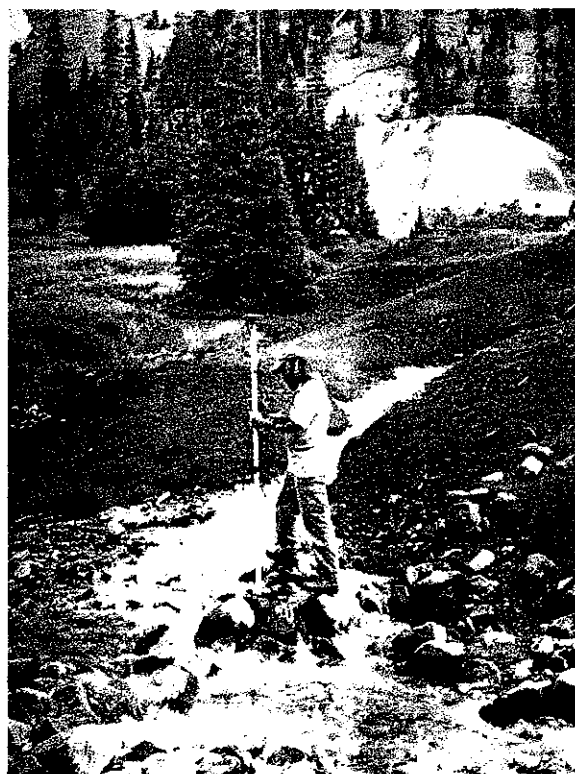
PHOTO 6

PPE from the adit discharge at the Red and Bonita Mine to Cement Creek. Note iron oxide staining on the same side of the Cement Creek as the PPE discharge point. J. Miller of START at PPE collecting GPS location data.

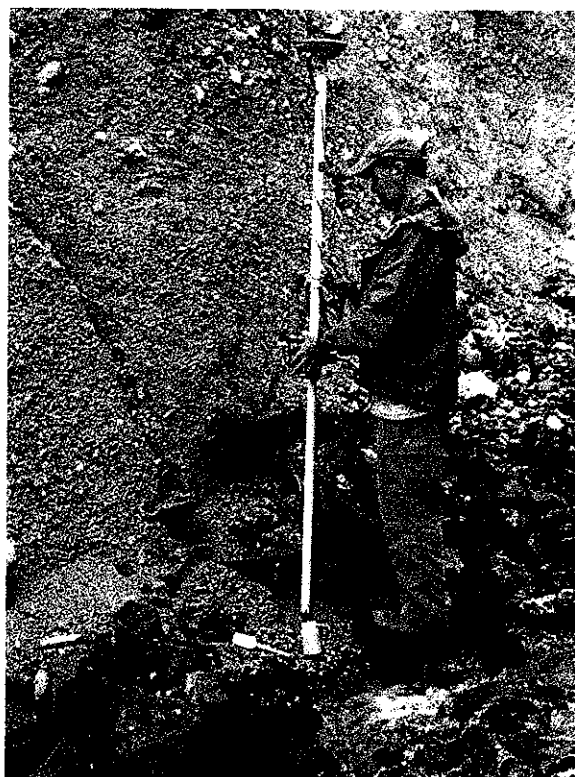
PHOTO 7

Gold King 7 Level Mine waste rock pile being eroded by the North Fork of Cement Creek. Note the erosion rills on the waste rock pile and undercutting by stream. J. Miller of START collects source sample UASO015 GPS coordinates.

Four samples of the waste rock pile at the Gold King 7 Level Mine were collected in accordance with the approved FSP. Sample UASO015 was collected from an area that was being actively eroded by the North Fork of Cement Creek, from material that appeared to be similar to the fine-grained limonite colored material (Appendix A, Photo 7). START personnel also collected source/soil samples from each of the three types of waste material identified with the field XRF. One Matrix Spike/Matrix Spike Duplicate (MS/MSD) sample was collected with the sample from location UASO018.

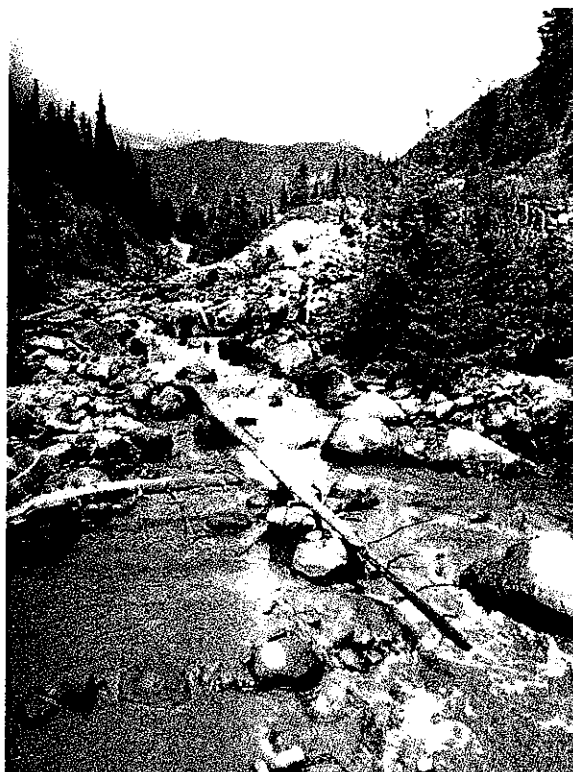
PHOTO 9

Cement Creek immediately downstream of confluence with N. Fork of Cement Creek draining from Gold King 7 Level Mine. J. Miller of START at PPE collecting GPS coordinates.

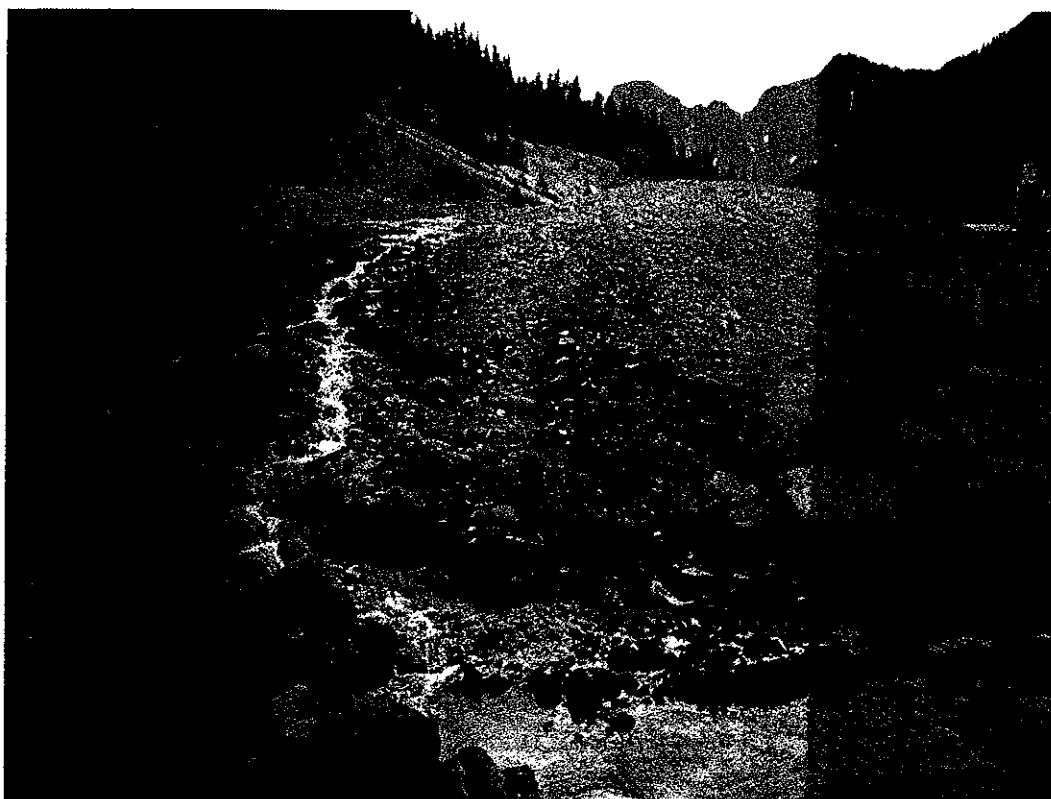
PHOTO 10

PPE from the American Tunnel outlet entering into Cement Creek. Note strong iron oxide staining downstream of PPE.

- **American Tunnel:** The discharge point for the American Tunnel is found just upstream of Gladstone where the discharge emerges from the diversion structure and flows approximately 200 feet westward to its PPE with Cement Creek. Strong iron oxide precipitate staining of the discharge and Cement Creek below the PPE was observed in August 2011 (Appendix A, Photo 10).

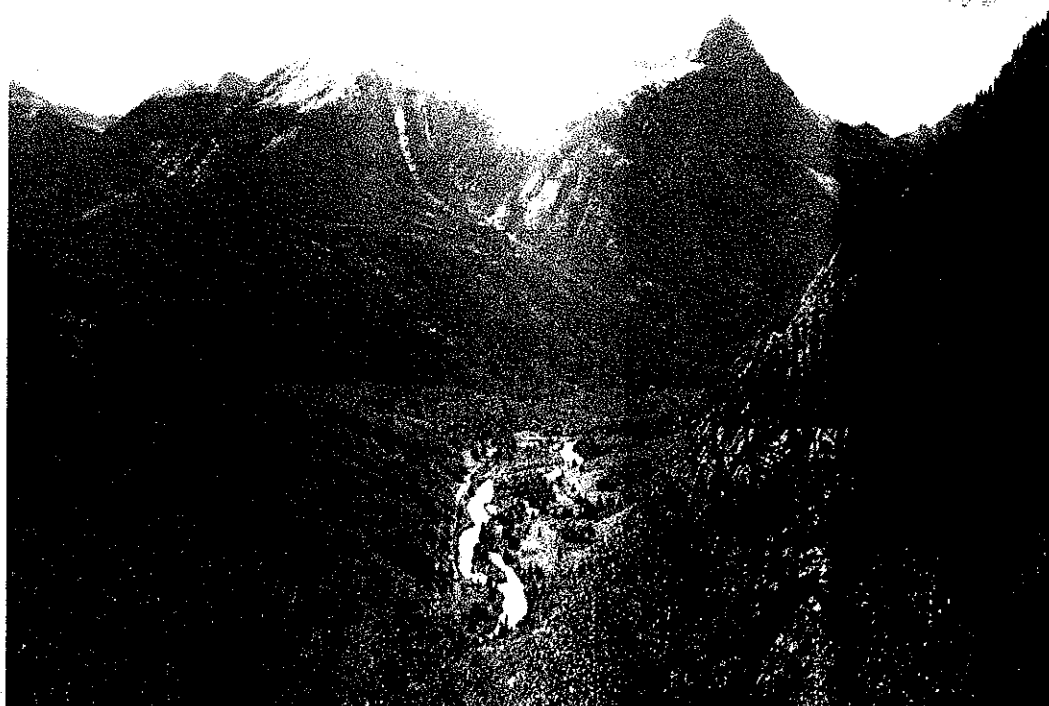
PHOTO 11

Elk Park is an open area in the Animas River Canyon below Silverton where the State of Colorado conducts electroshocking and passengers from the Durango & Silverton Narrow Gauge Railroad are dropped off to fish the Animas River. Access is also gained from Molas Lake via the Colorado Trail which crosses the Animas River in Elk Park.

START investigated the potential fishing activity along the Animas River downstream of the confluence of Cement Creek with the Animas River, south of Silverton, Colorado. Elk Park, an open area in the Animas River Canyon where the State of Colorado performs fish count studies every 5 years, was investigated. A fishing lure was found in a tree along the river bank, but no fishermen were observed during the investigation (Appendix A, Photos 11 and 12).
